2009/2010 Annual Inspection Report

EAST SABINE LAKE HYDROLOGIC RESTORATION PROJECT (CS-32)

State Project Number CS-32
Priority Project List 10

March 11 & 18, 2010
Cameron Parish

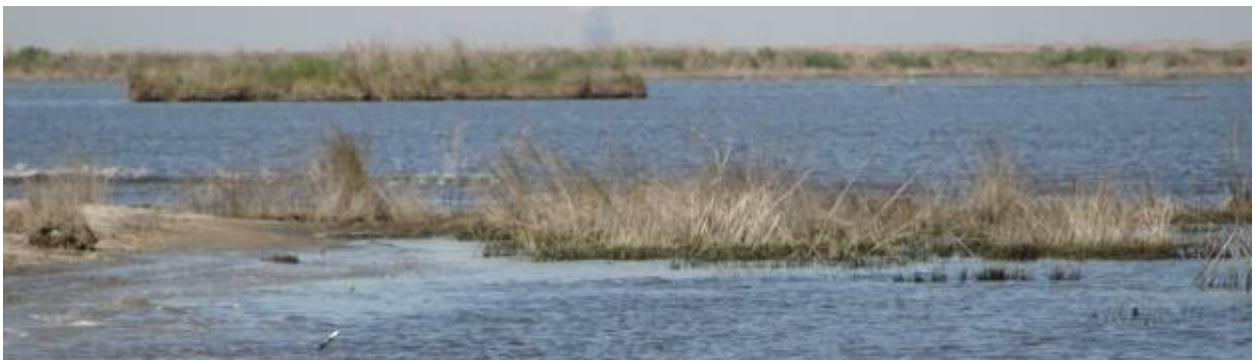
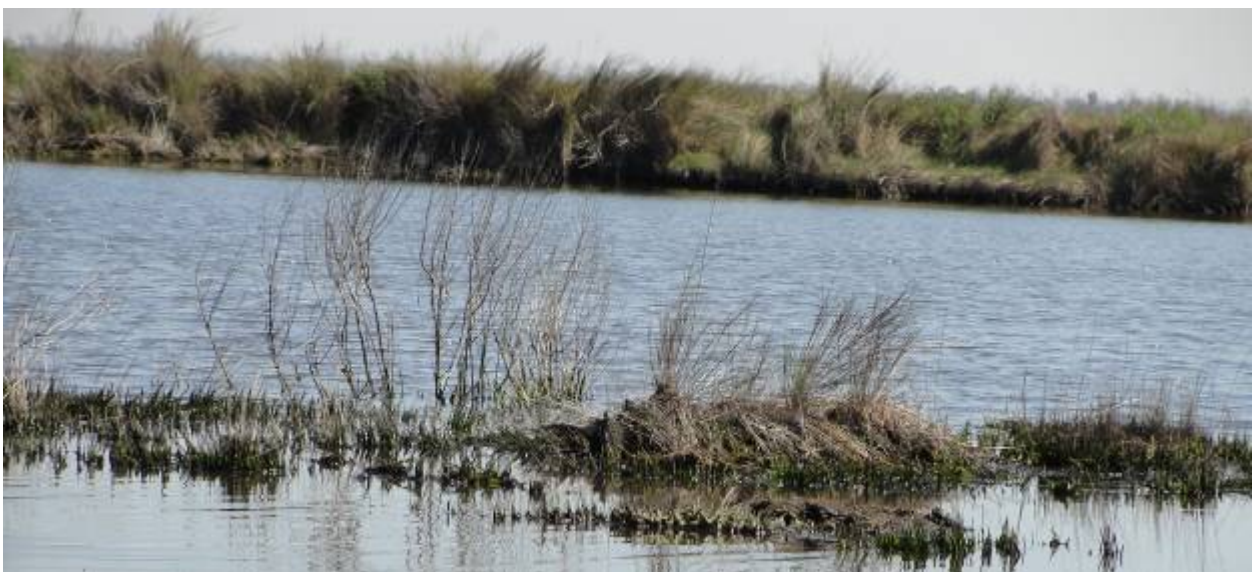
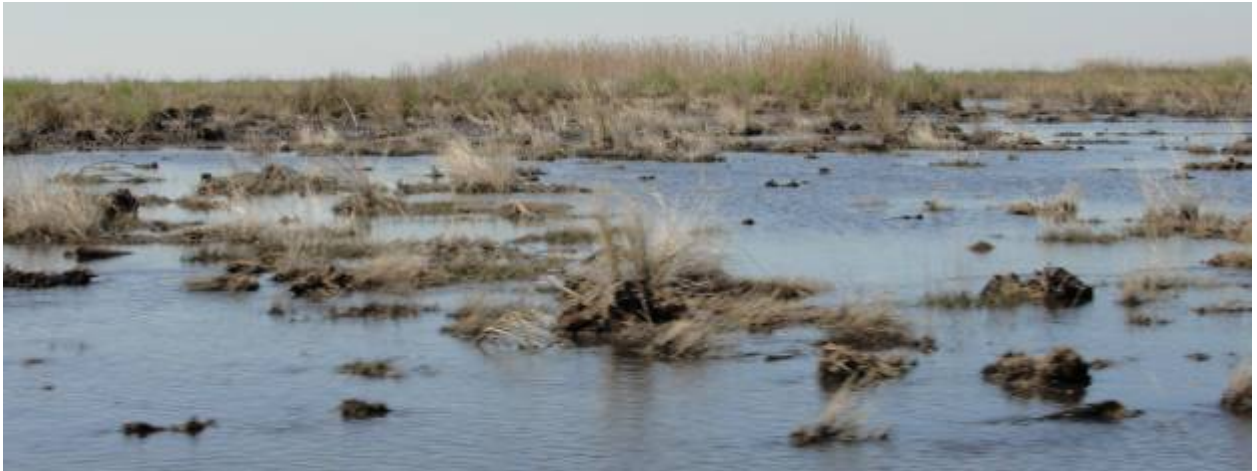
Condition of existing natural emergent marsh next to terraces:

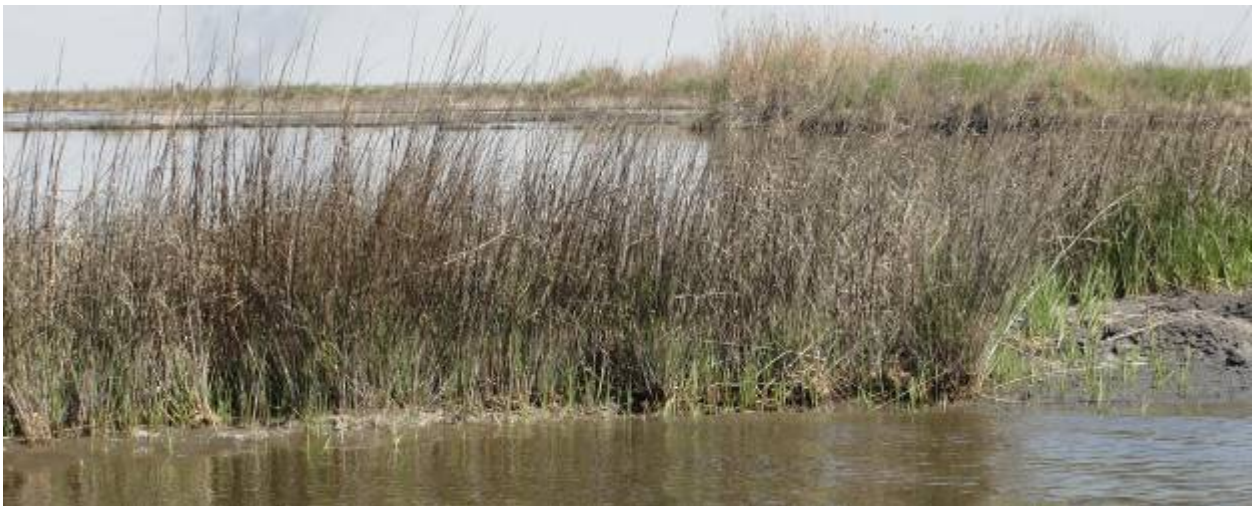
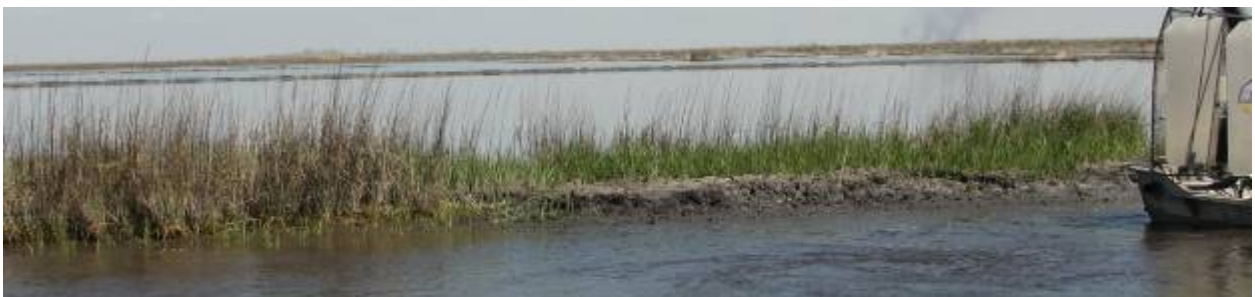
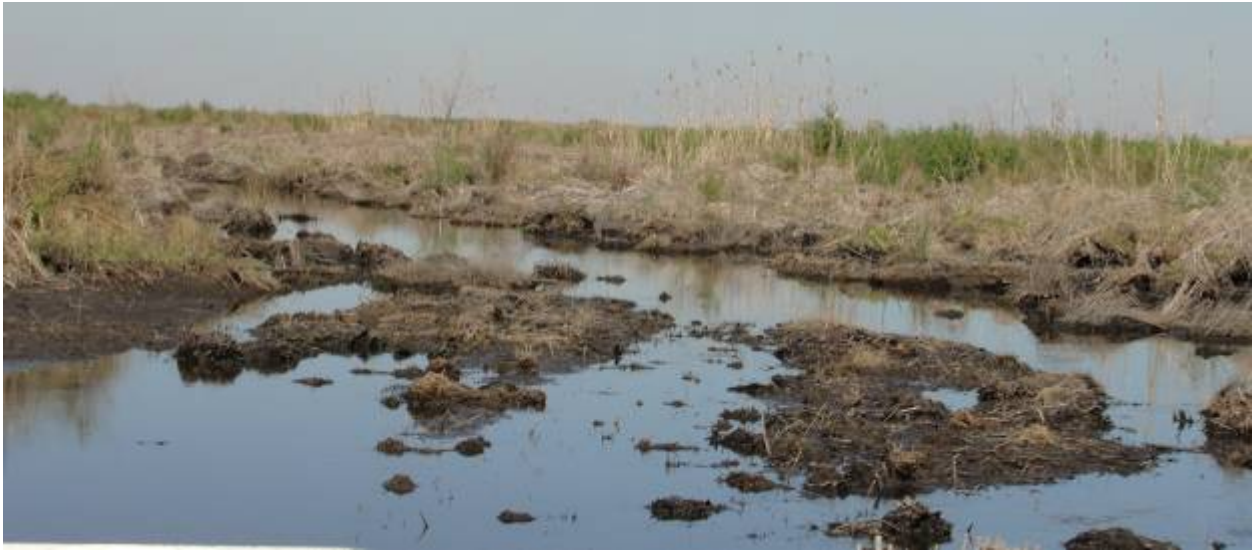
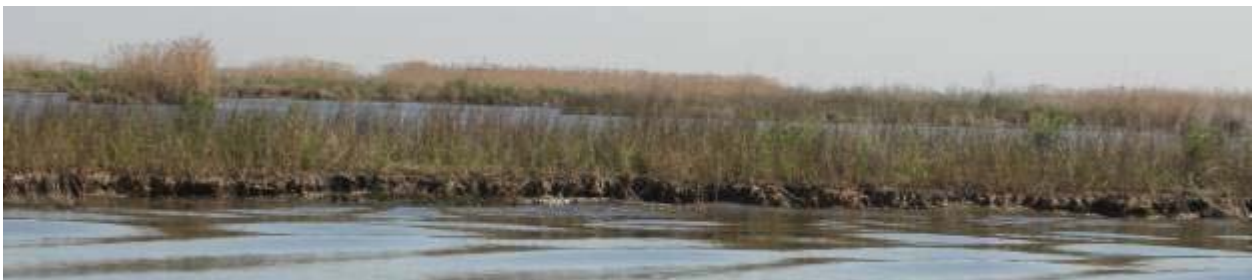
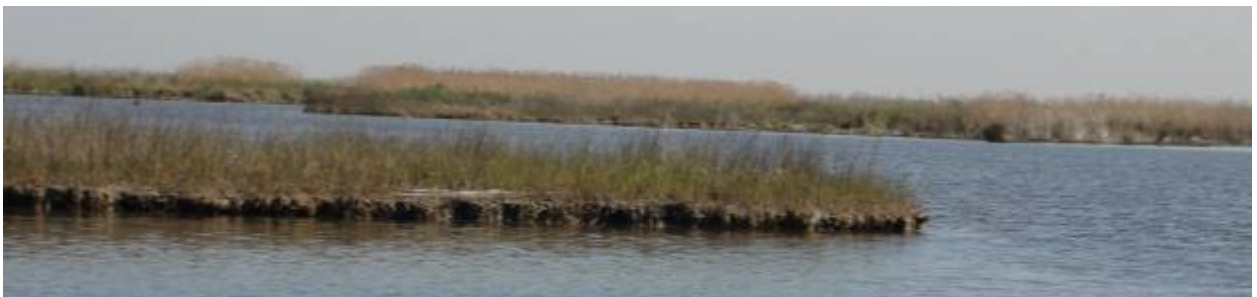
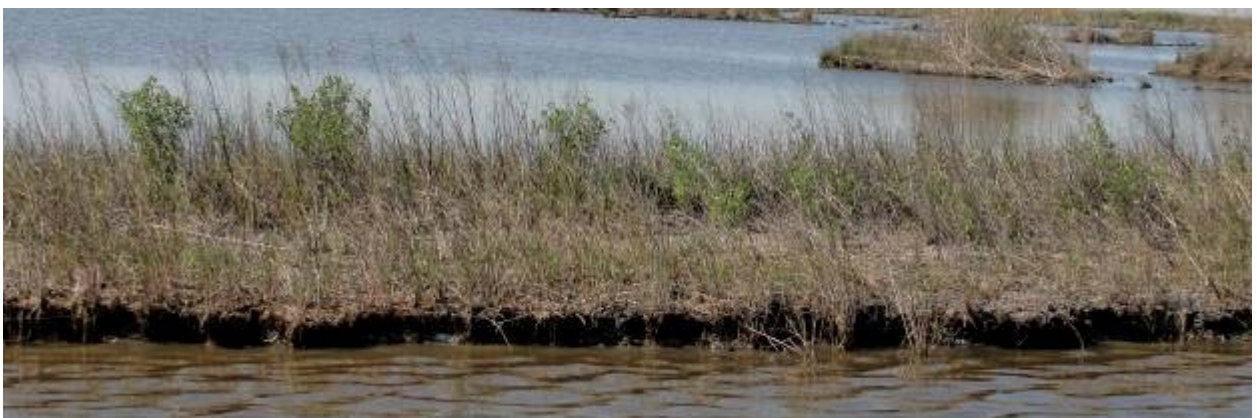
Contrast above with the appearance of the condition of those older plantings in March 2010:

Although mainly conjecture, weather could have played a causative role in the overall plant condition we observed. Installation of the CU-1B plantings was completed in July 2009 which turned out to be less than an ideal time for bare-root plant establishment. Following the extreme and prolonged saltwater inundation from hurricane Ike surge in September 2008, southwest LA experienced severe drought conditions in the first half of 2009, with a precipitation deficit persisting until October. In addition, discreet and continuous measurements during the summer revealed that salinities in the project area were significantly higher than normal - greater than 12ppt, and with water temperatures remaining around 85°F until September (CRMS). This may have led to stagnant or phytotoxic soil conditions until precipitation levels returned to normal in October, but by that time it was already at the end of the growing season when plants are beginning to senesce. This period was then followed by an unusually cold winter pattern that began in late November and persisted throughout south Louisiana. Minimum temperatures frequently dropped into the 30's or below for at least half of Jan and Feb 2010 dates (NWS monthly summaries for the Lake Charles/Port Arthur area). It is possible that the newest plantings experienced higher mortality or dieback of aboveground tissue from the combination of elevated stress during initial acclimation and then additional impact by the ensuing cold temperatures to any new shoot growth that did occur. Further, following a typical winter season, robust new growth is not usually seen in smooth cordgrass until March when warmer spring temperatures become entrenched. So it is also possible that this year's new growth expected for all plants in the area may still be absent because it's been retarded by the persistent winter weather pattern and the late freeze in early March.

Because of the high uncertainty at this date of what below-ground tissue remains viable, a mortality rate or pattern cannot reasonably be determined for any of the plantings, regardless of age. I recommend returning to the project site in September near the end of this year's growing season when a much more accurate assessment of the extent of plant survival can be made. Collection and analysis of soil samples may also provide additional insight in discerning actual causes of the apparent poor performance of all the plants.

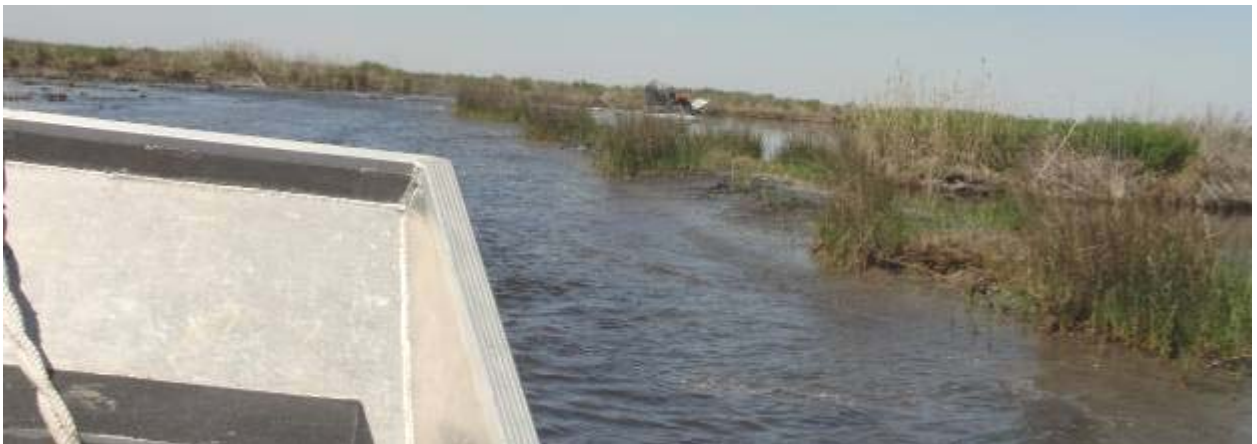
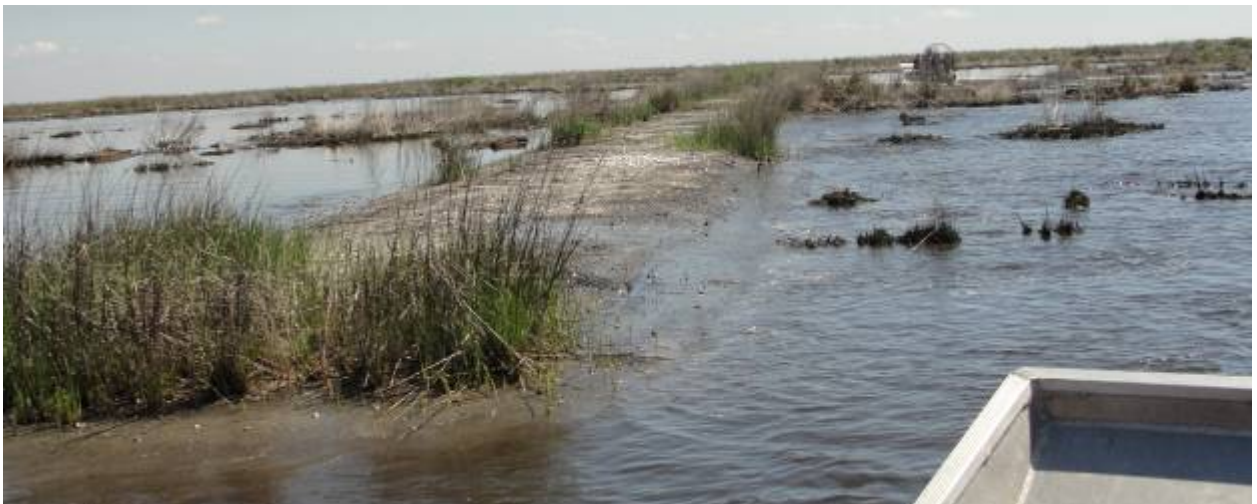
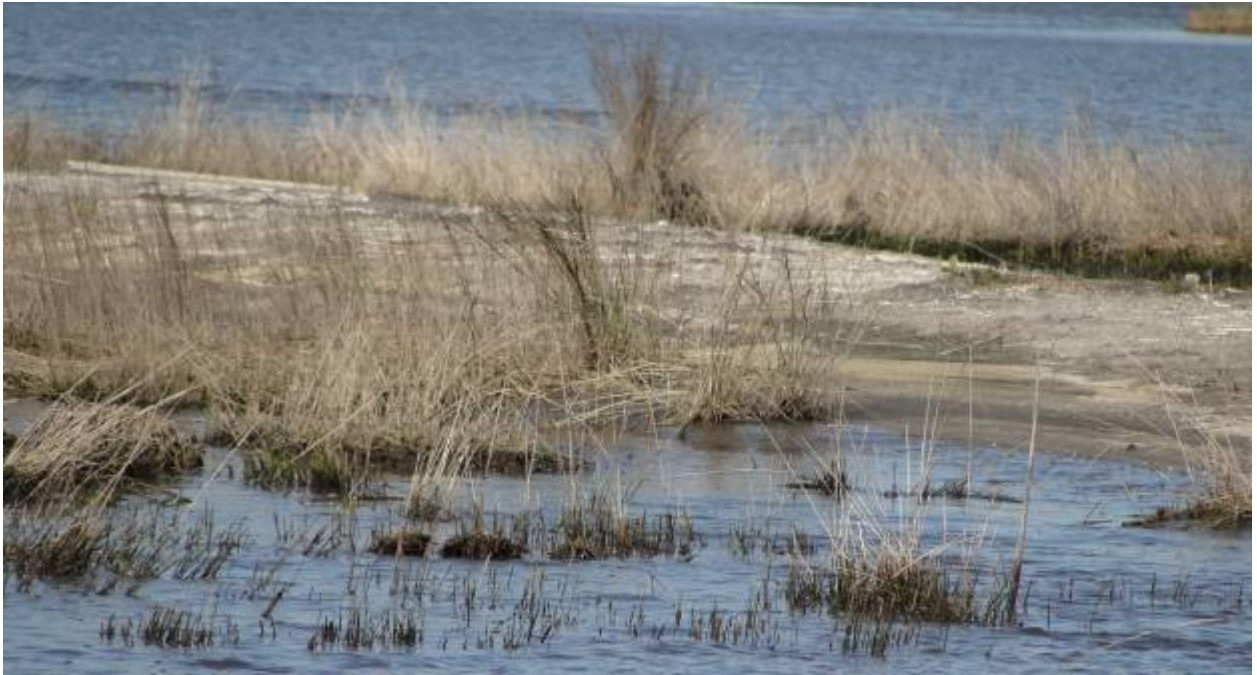
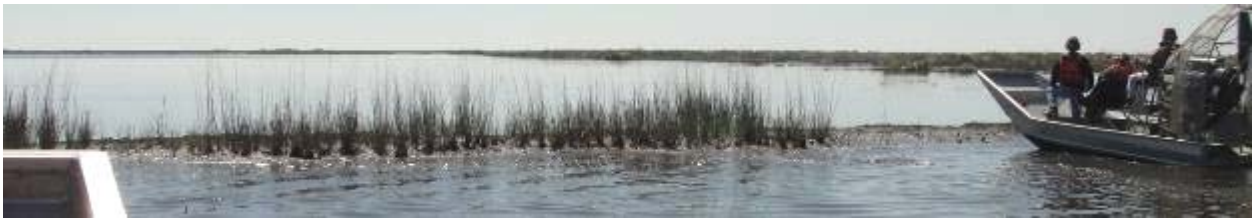
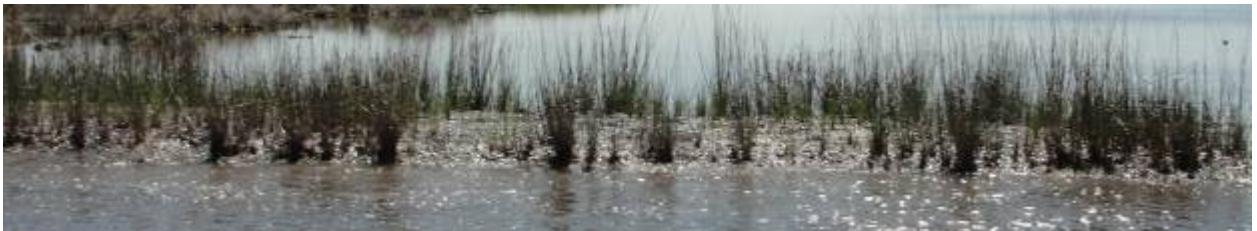
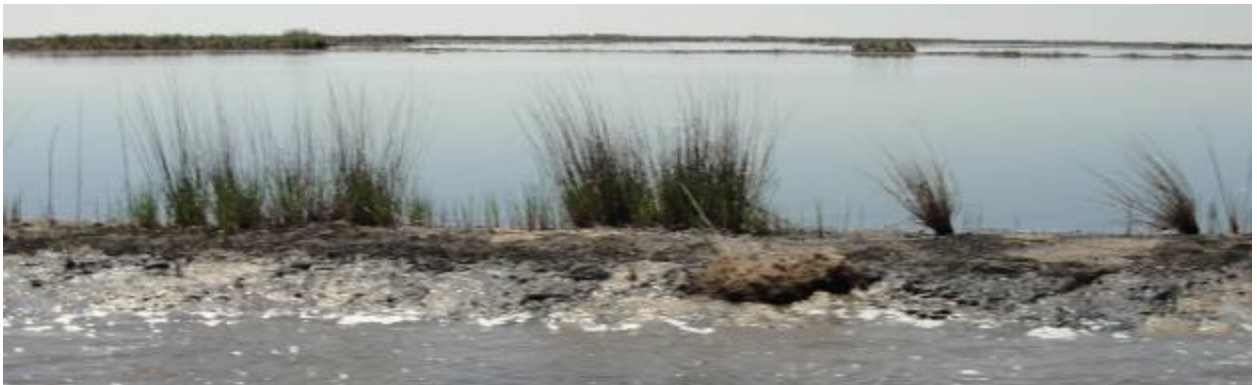
March 2010 condition of terrace segments with combination of older and recent plantings:

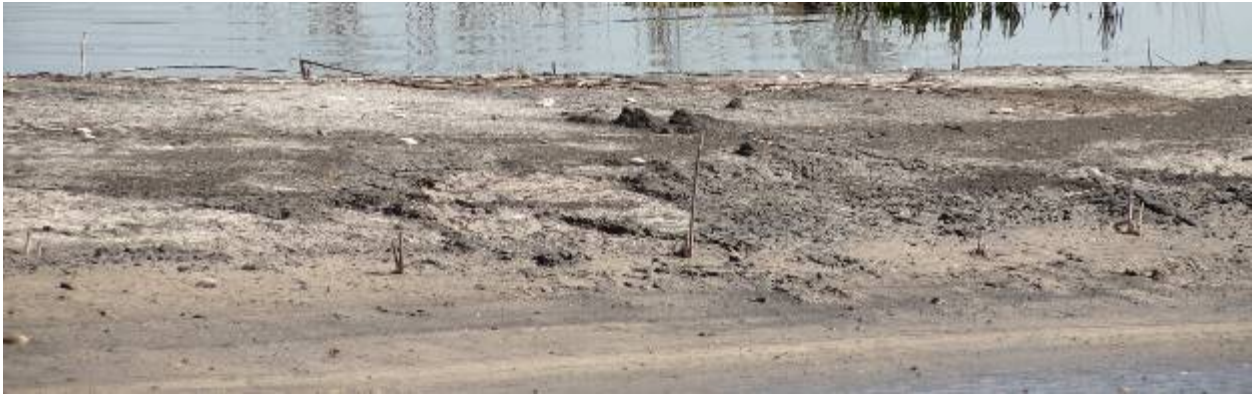
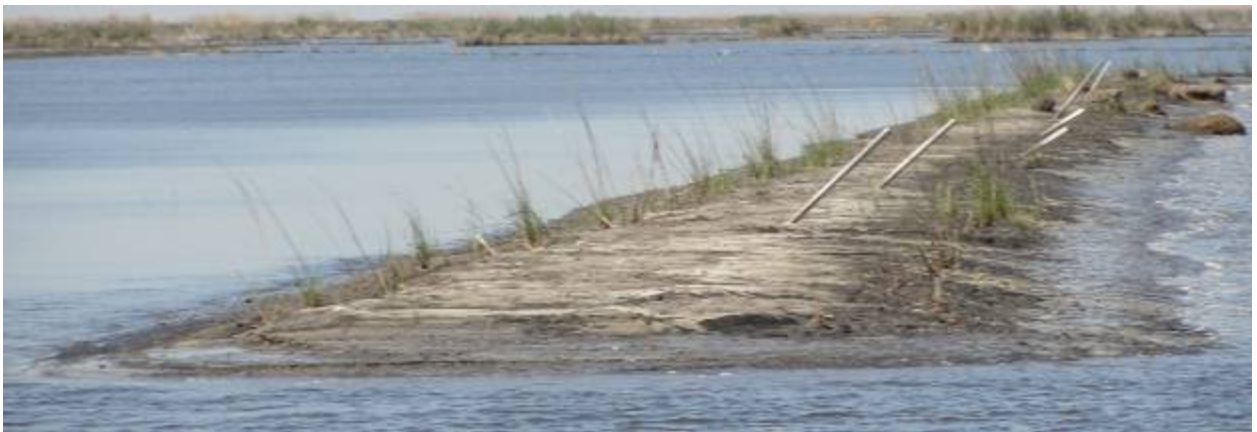
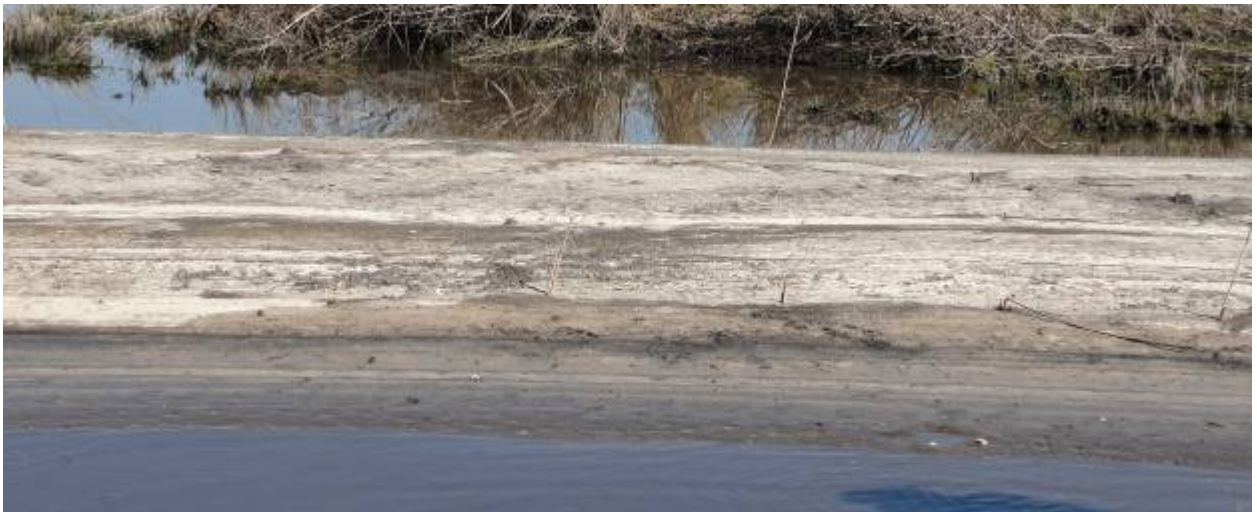
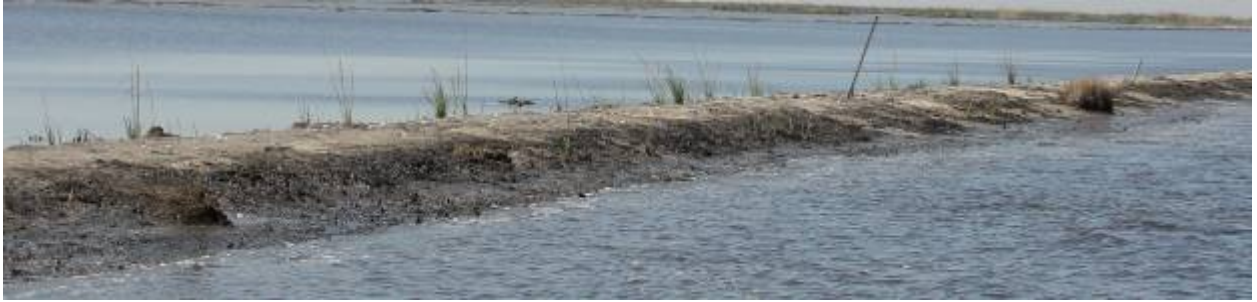
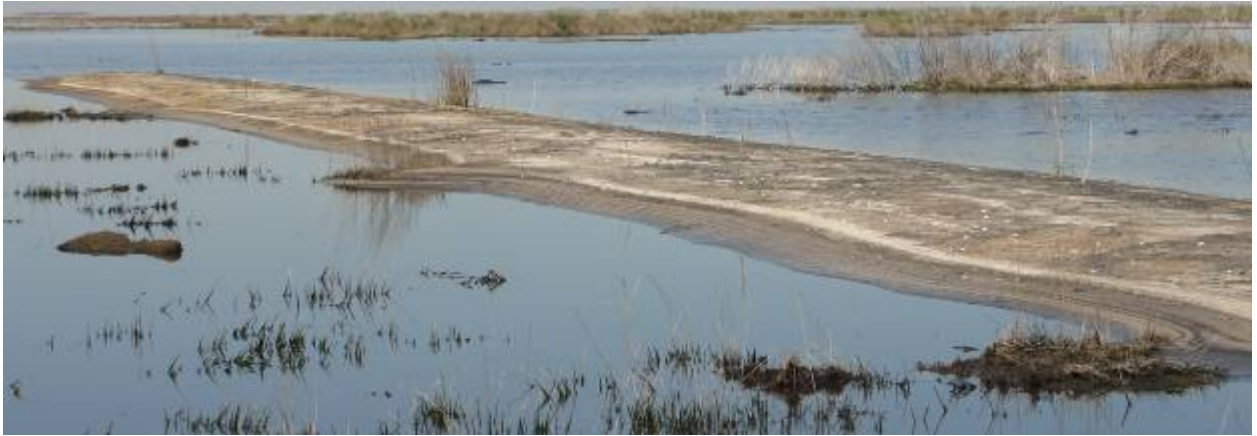
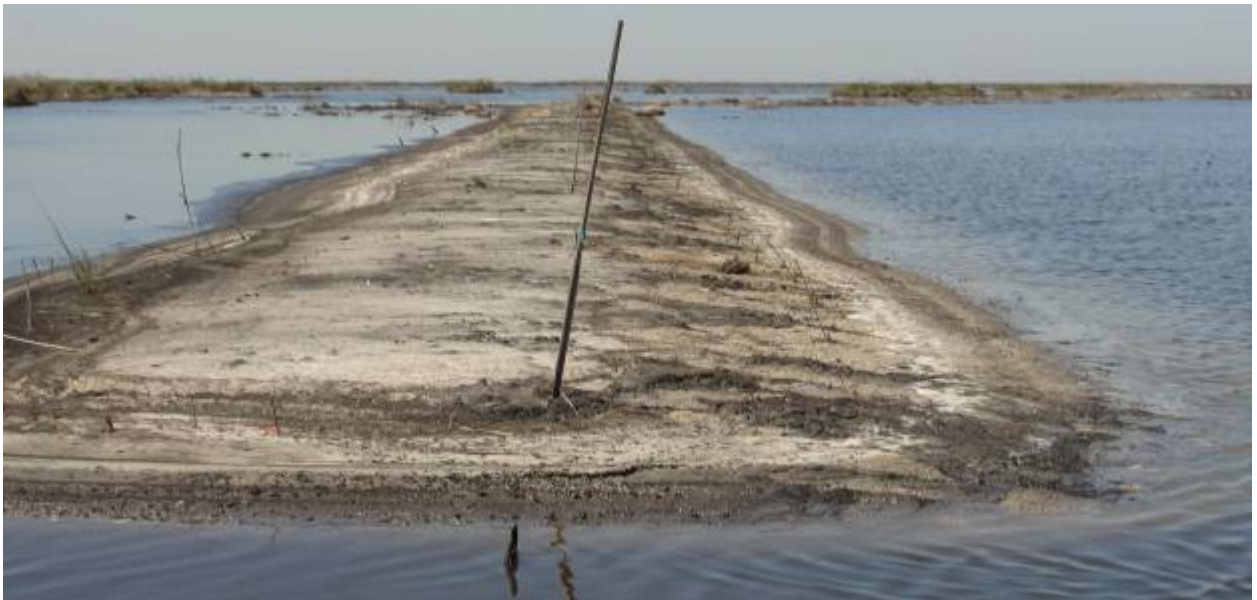
March 2010 condition of newest plantings:

For the newest CU-1B plantings, it is not likely that the source of the plants is a factor contributing to their current state, as the contract plants came from two different nurseries, one in Cameron Parish and one in Lafourche Parish, and all of the remaining plants from the other CU's generally appeared to be in the same condition on the date of this field trip.

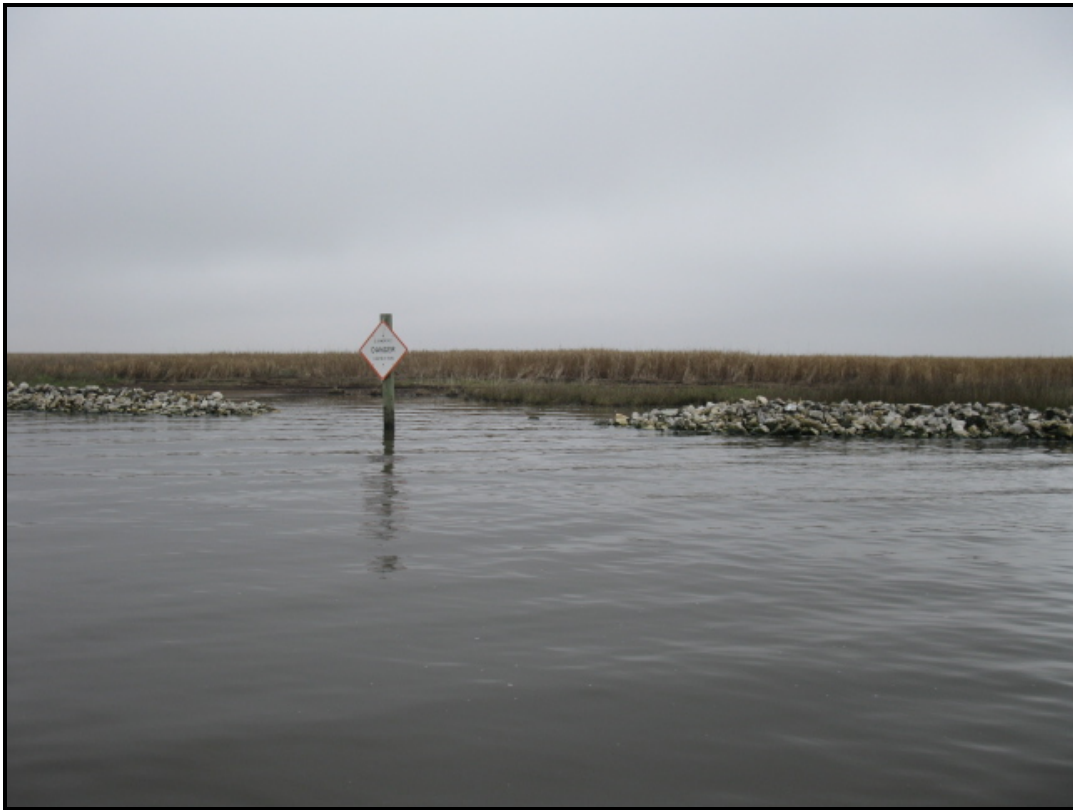
The rock dike is good condition since completion of construction. There are a few low areas of rock dike that were identified with GPS coordinates and which will be monitored in future inspections for any changes that may be detrimental to the project and require maintenance. Areas behind the rock dike are beginning to show signs of accretion. Vegetation behind the rock dike along the northern reaches has grown out and is touching the back side of the dike. (Photos: Appendix B, Photos 1 - 3)

Photo No.1 -Typical fish dip along rock dike with warning sign

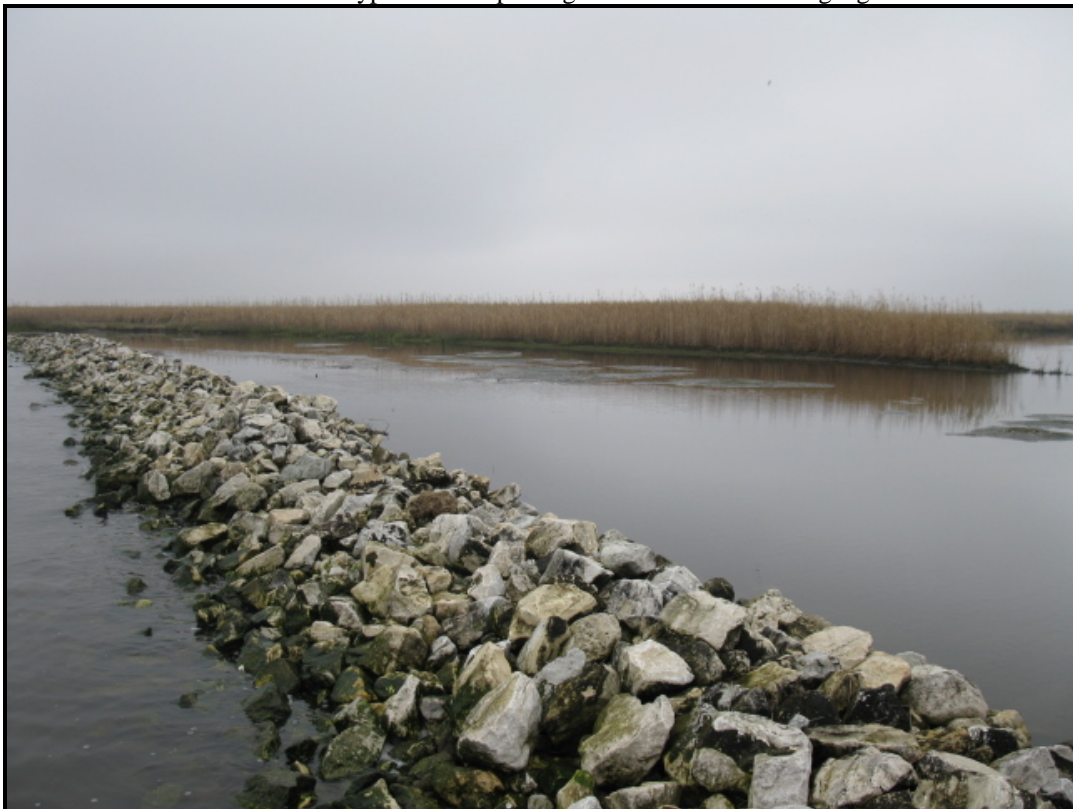
Photo No. 2 -Typical rock dike showing accretion between dike and shoreline

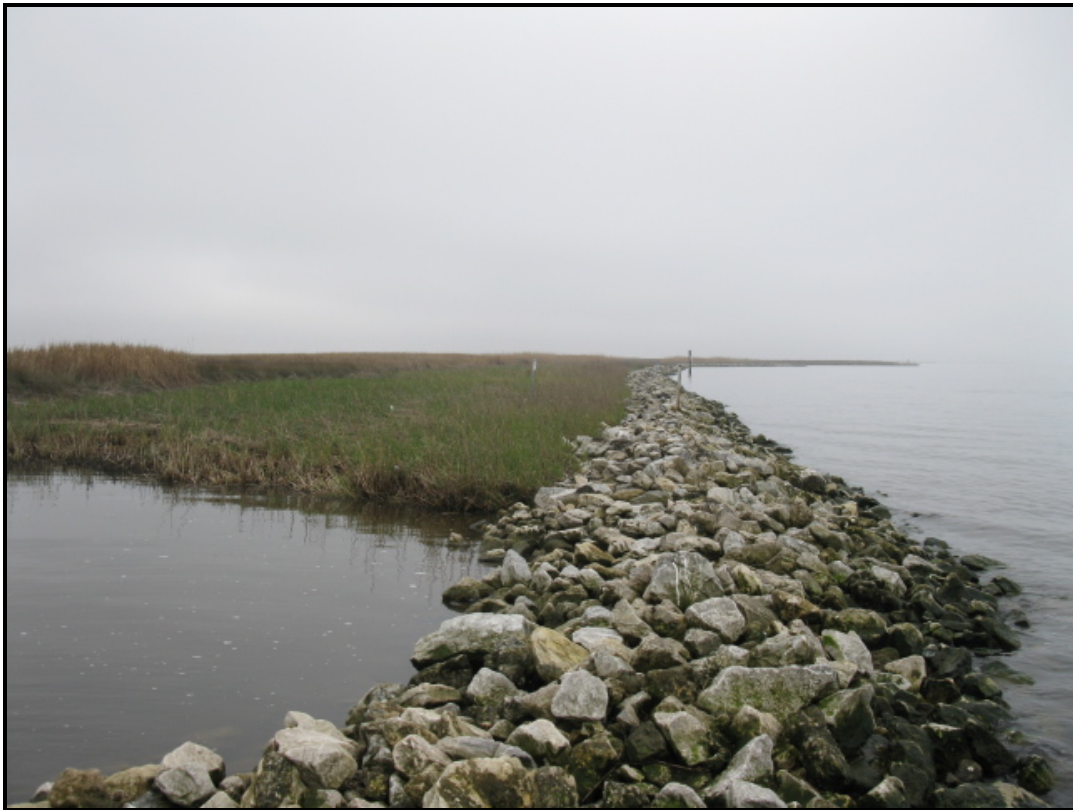
Photo No. 3 – Rock dike along northern reach with vegetation touching back side of dike

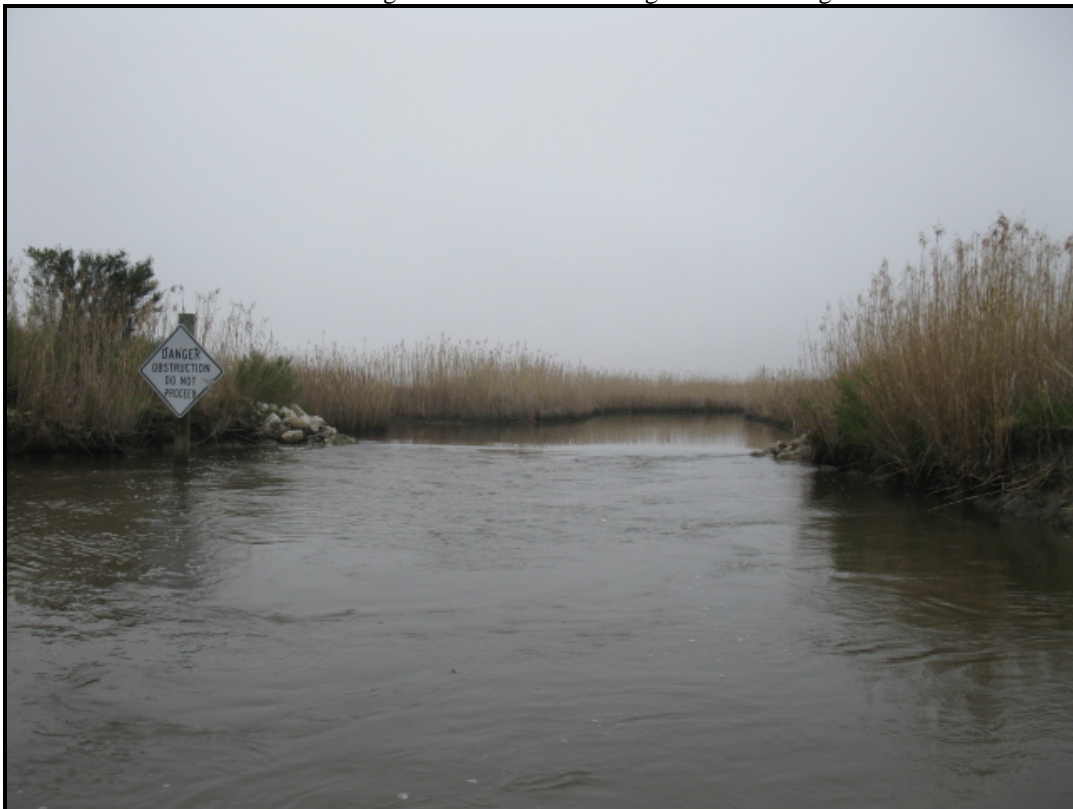
The rock weir is in good condition after being rebuilt after Hurricane Rita. No signs of erosion are evident around the bank slopes. (Photos: Appendix B, Photo 4).

Photo No. 4 – Pines Ridge Weir

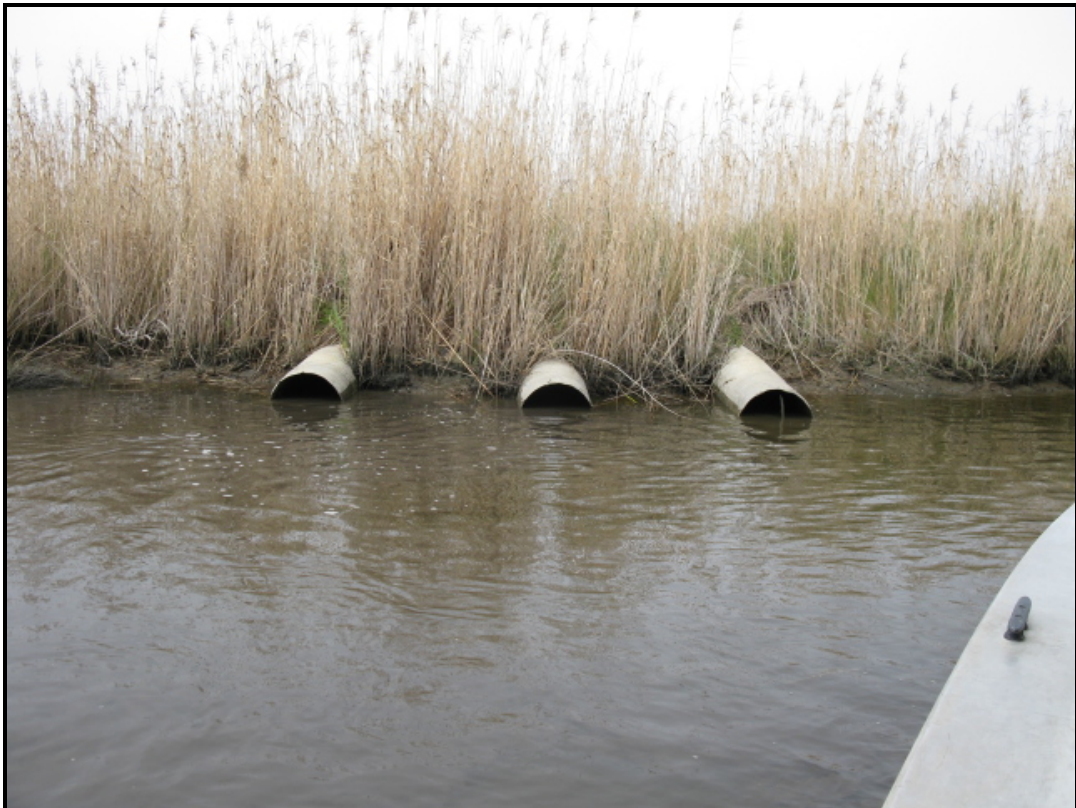
The culverts at this location are in good condition. No erosion was evident at this site. There was difficulty in getting to and from this site by cabin boat. Future inspections will require the use of an airboat. (Photos: Appendix B, Photo 5).

Photo No. 5 – Bridge Bayou Culverts
